**ON-SITE AIR BAG INVESTIGATION**

CASE NO. - 96-05  
FLEET - PRIVATE VEHICLE  
LOCATION -  
ACCIDENT DATE - 1996

Case Vehicle: 1995 Volkswagen Golf III City, Five-door Hatchback

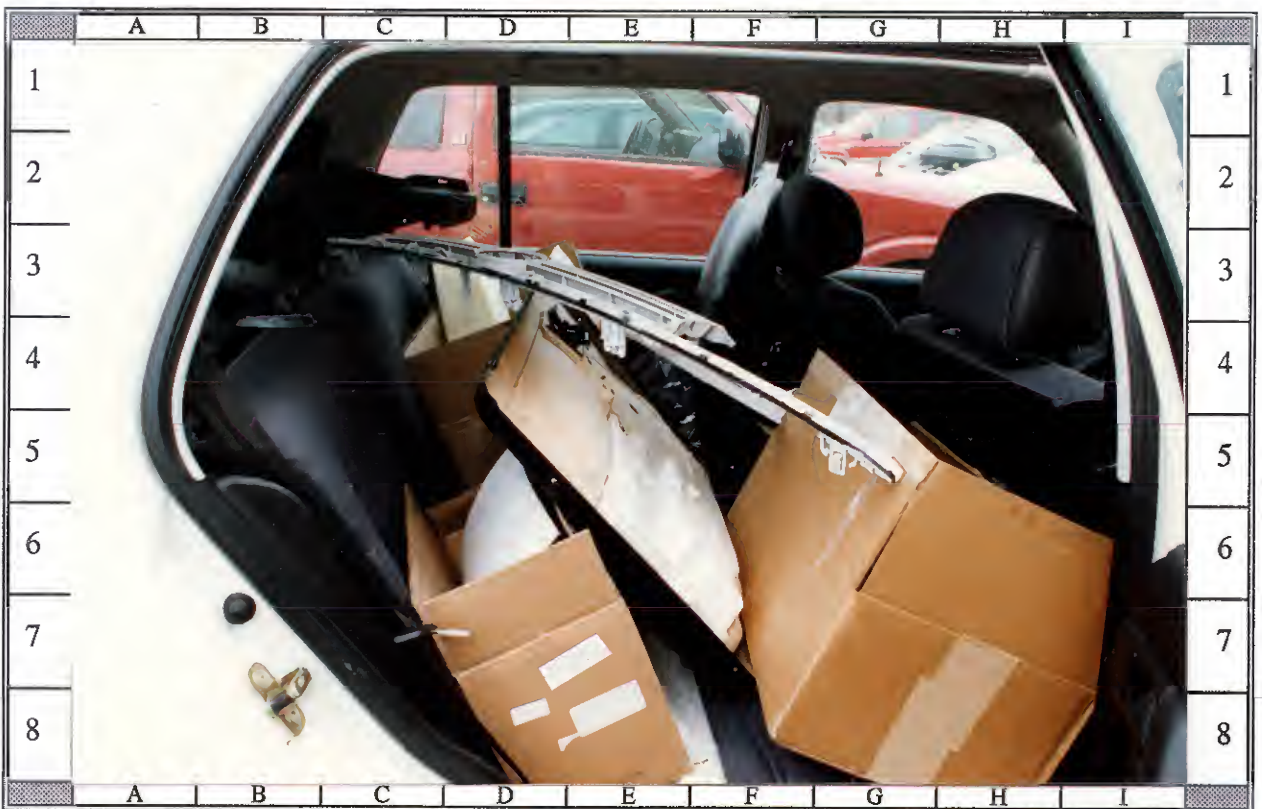
# 44: Case Vehicle's rear seating area showing stored replacement parts in back seat;  
NOTE: adjustable front seat head restraints and 3-point outboard rear safety belts

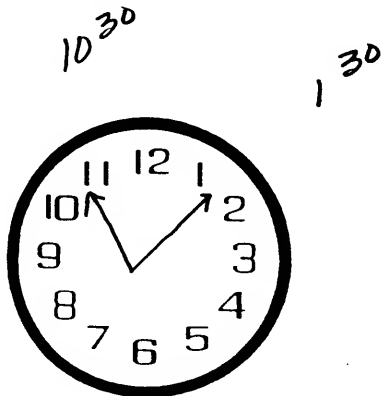
## 7. SKETCH LOCATION OF CIRCULAR AIR BAG VENT PORTS

Both vent  
Diameters  
2.5 cm
